## Inspection Report

**Property Address:**  
100 Any where  
Williamsburg NY 11216

**INSPECT THIS, HOME INSPECTIONS LLC**

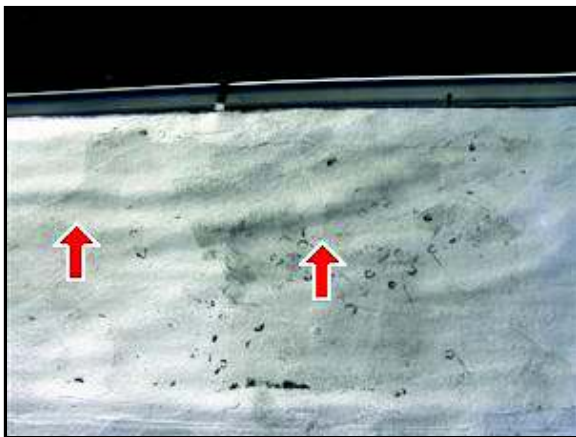
1.0 Picture 2 Bubbles and lifting

**Recommend evaluation and repair by a licensed roofing contractor.**

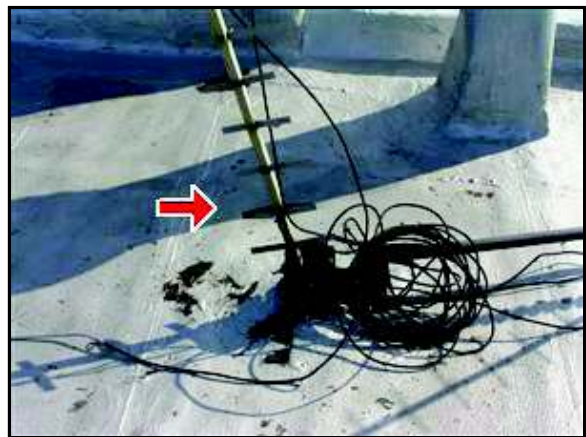
1.0 Picture 3 Antenna digging into roof at base

1.0 Picture 4 Broken antenna digging into roofing

**Old broken antenna in middle of roof digging into roofing. Should be removed by a qualified handy-man.**

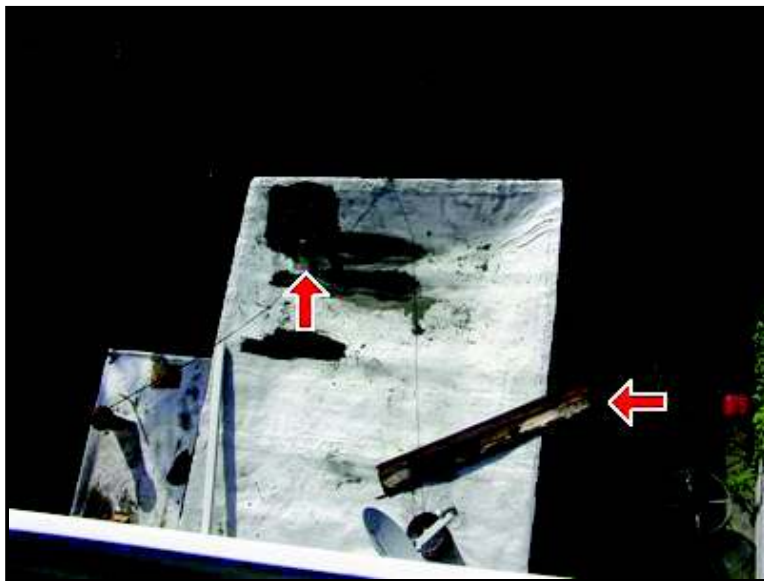
1.0 Picture 5 2" x 4" laying on Roof

**Lower roof over extension 2" x 4" laying on roof, roofing is dished toward down spout. Recommend converting to a pitched roof system with gutter and down spout.**

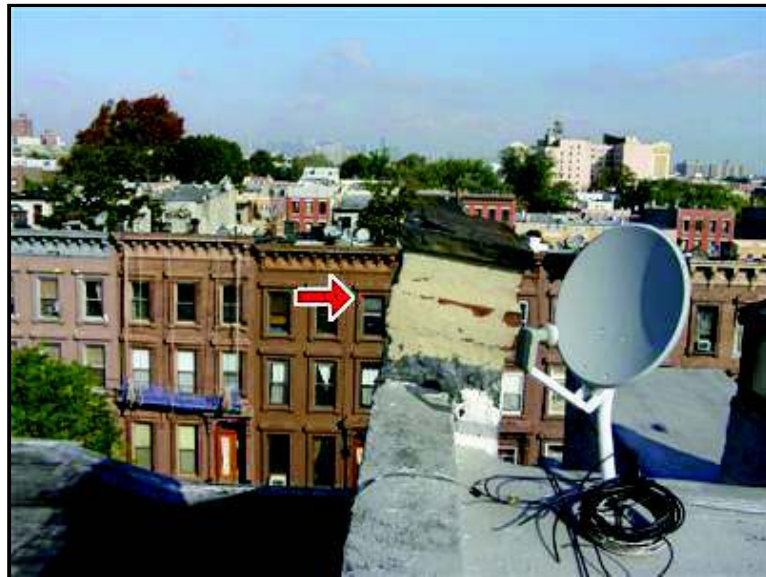
1.2 Picture 3 northeast chimney out of plum

1.2 Picture 4 Northwest chimney out of plum

**Recommend evaluation and repair by a licensed mason contractor to repair chimneys.**

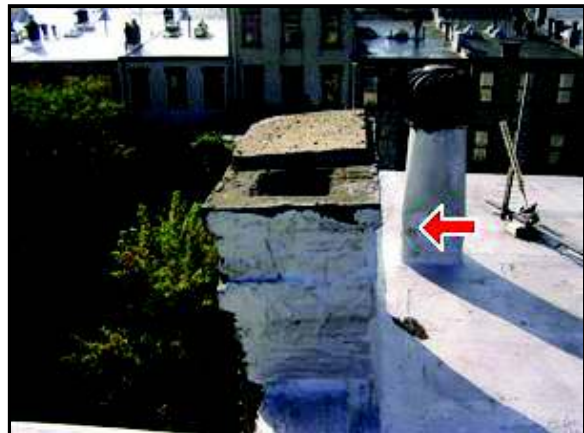
1.2 Picture 6 Southeast chimney fireplace  
flues covered

**Recommend evaluation of flue pipe if fireplaces are to be renovated.**

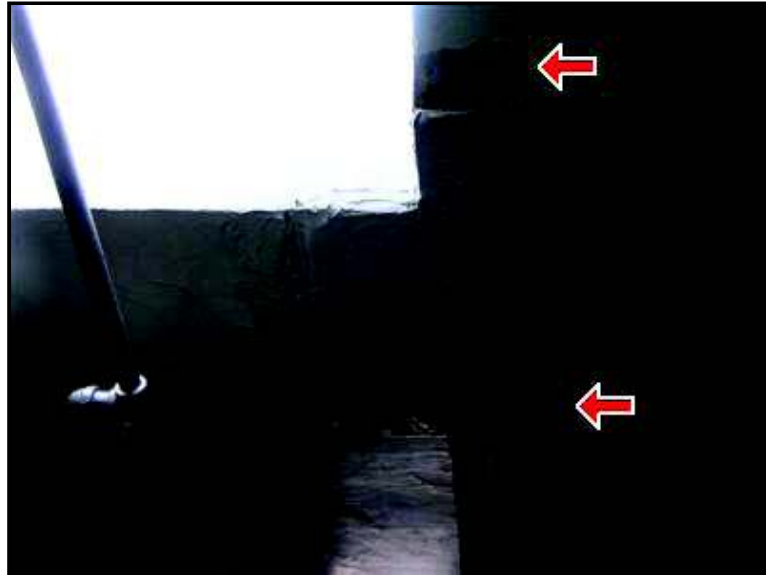
4.0 Picture 1 Fifth floor ceiling water damage around skylight

4.0 Picture 3 Front bedroom plaster cracked and peeling

**Plaster ceiling in front bedroom on fifth floor cracked and peeling around skylight. Tenant stated that water leaks in when raining.**

**Recommend evaluation and repair by a licensed drywall contractor. Not before roof leaks are repaired.**

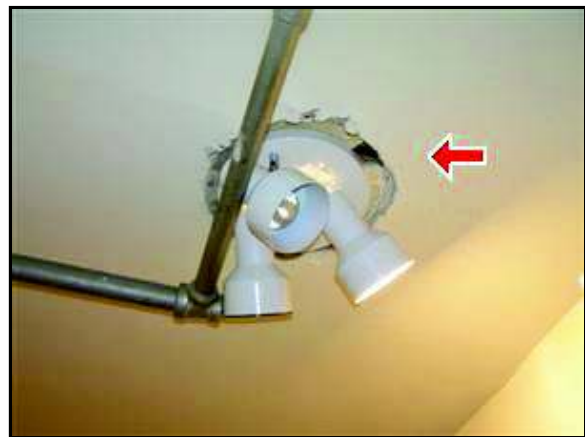
4.0 Picture 5 Fifth floor kitchen light not installed properly

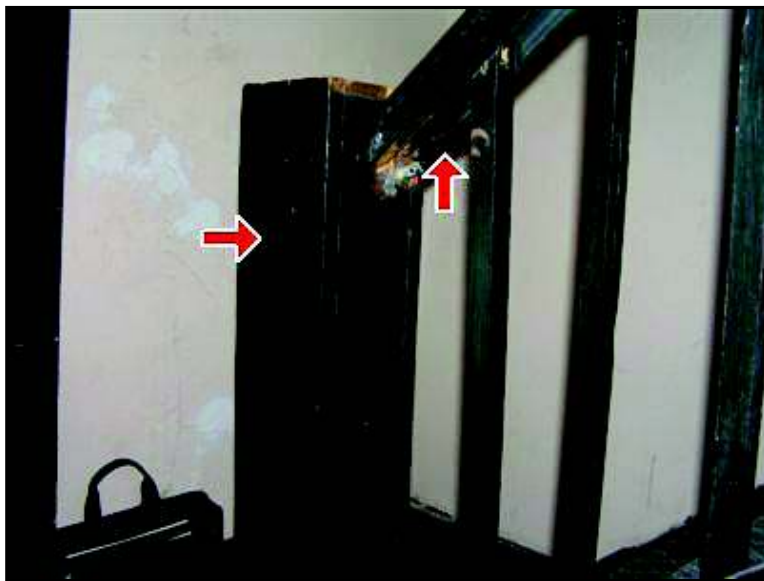
4.3 Picture 1 Missing & loose baluster

4.3 Picture 2 newels loose

4.3 Picture 3 Fifth floor landing and railing pitched

**Railing and newels in stair well are loose with balusters missing and or loose. Fifth floor landing & railing not level. Stairs out of level pitching down toward center of house, from settlement. Recommend evaluation and repair by a licensed carpenter contractor.**

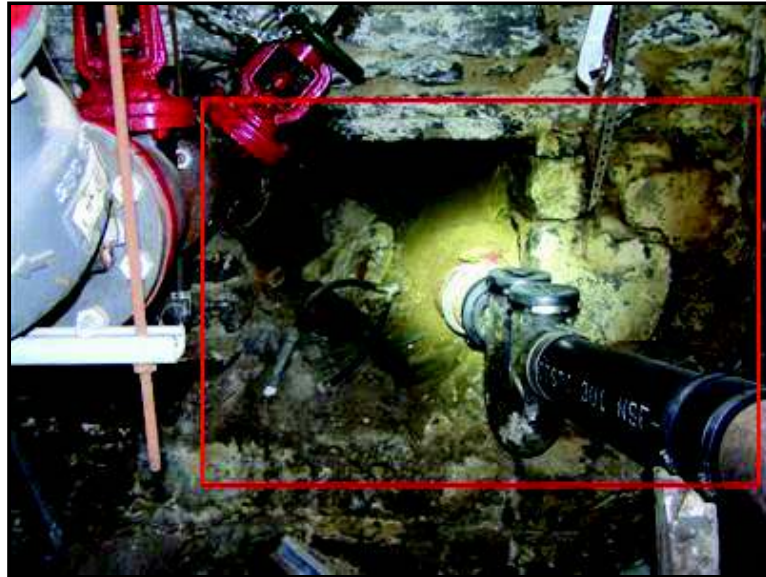
6.0 Picture 1 Hole in foundation

**Large hole in stone foundation at northeast corner at water service and waste line entrance. Recommend evaluation and repair by a licensed mason contractor.**

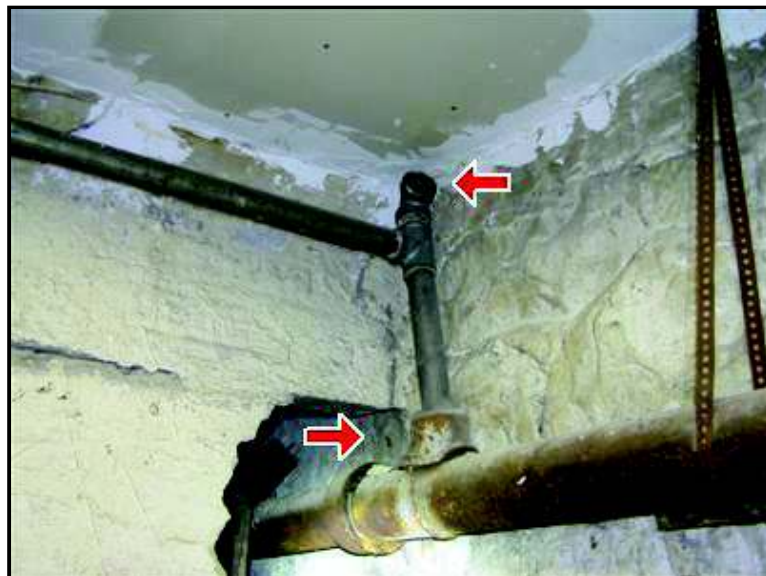
7.0 Picture 3 Open waste line

**Recommend evaluation and repair by a licensed plumbing contractor.**

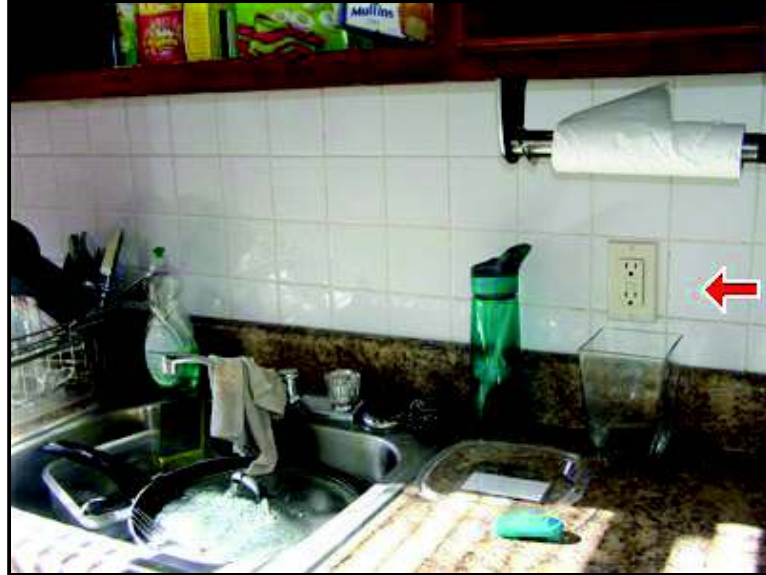
8.5 Picture 1 GFCI outlets in 2nd floor kitchen.

**Recommend installation of GFCI outlets in all kitchens and baths by a licensed electrical contractor.**

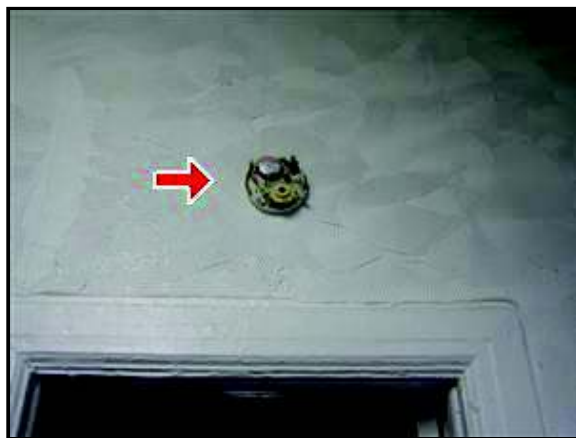
8.7 Picture 1 Battery missing 3rd floor apt.

**Recommend installation of dual current dual function smoke / carbon monoxide detectors through out house and common areas.**

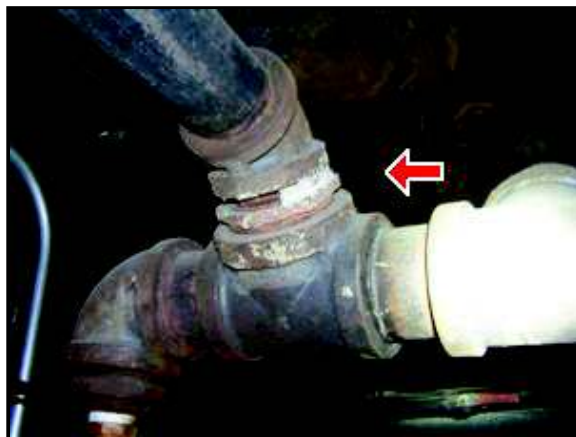
9.3 Picture 2 Some asbestoes residue left on pipes above boiler

9.3 Picture 3 Some asbestoes residue I

**Caution: Some asbestos residue left on pipes above boiler. Recommend evaluation and removal by a licensed asbestos abatement contractor.**
