## **Inspection Report**

**Property Address:**  
100 Any where  
Williamsburg NY 11216

**INSPECT THIS, HOME INSPECTIONS LLC**

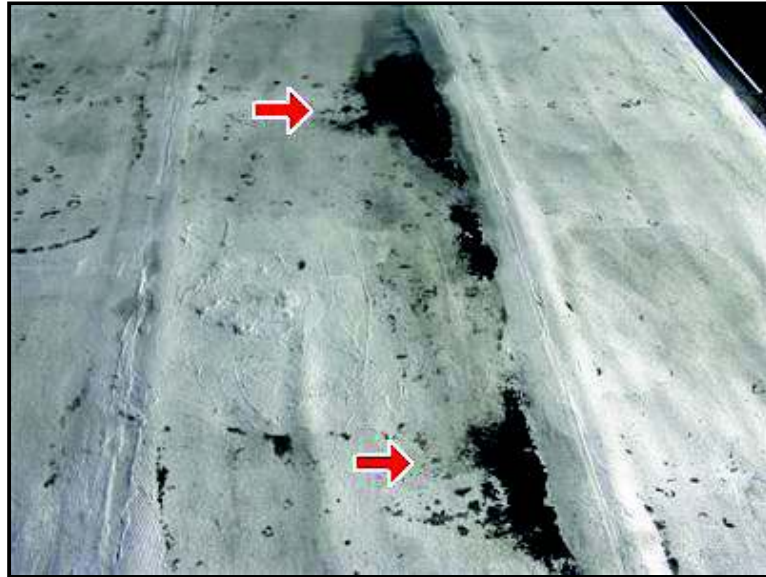
1.0 Picture 1 Roof covering wearing

**Roof covering showing signs of wear near rear last section before gutter.**

**Recommend evaluation and repair by a licensed roofing contractor.**

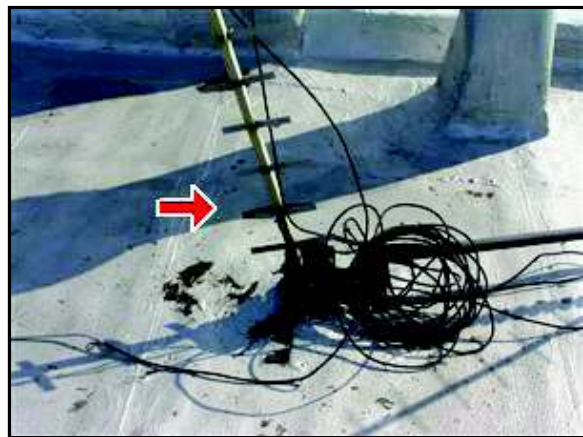
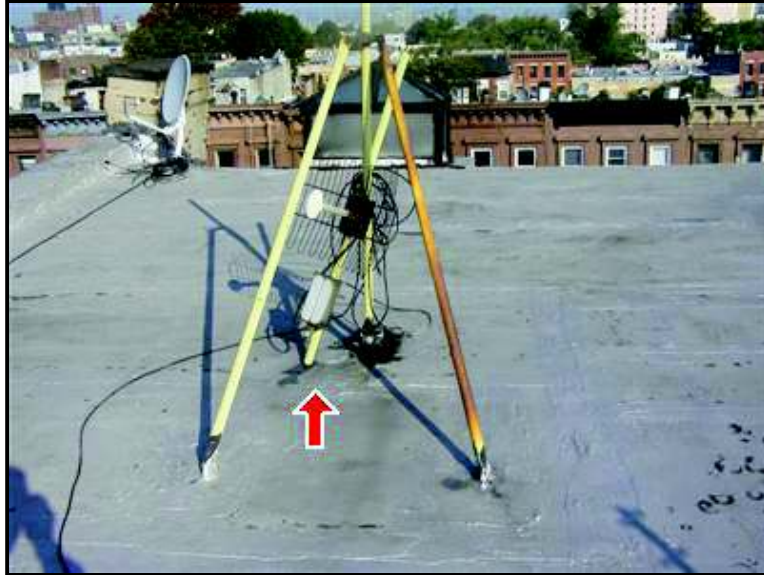
1.0 Picture 3 Antenna digging into roof at base

1.0 Picture 4 Broken antenna digging into roofing

**Old broken antenna in middle of roof digging into roofing. Should be removed by a qualified handy-man.**

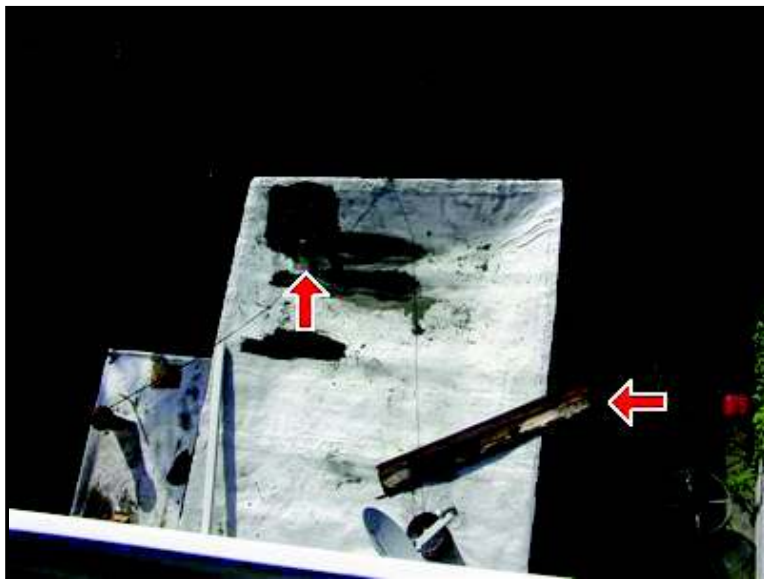
1.0 Picture 5 2" x 4" laying on Roof

**Lower roof over extension 2" x 4" laying on roof, roofing is dished toward down spout. Recommend converting to a pitched roof system with gutter and down spout.**

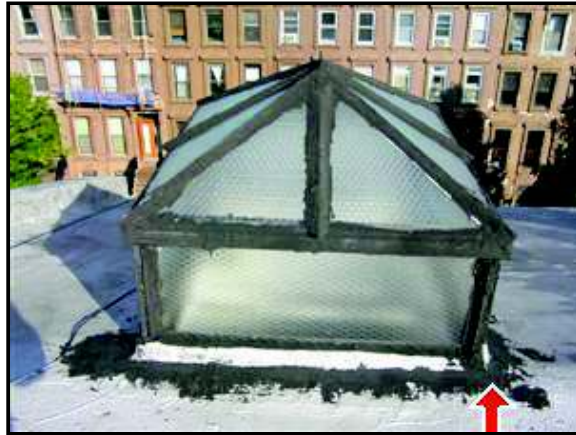
1.2 Picture 1 Front bedroom skylight

**Flashing around bedroom skylight leaking into 5th floor apartment. Recommend evaluation and repair by a licensed roofing contractor.**

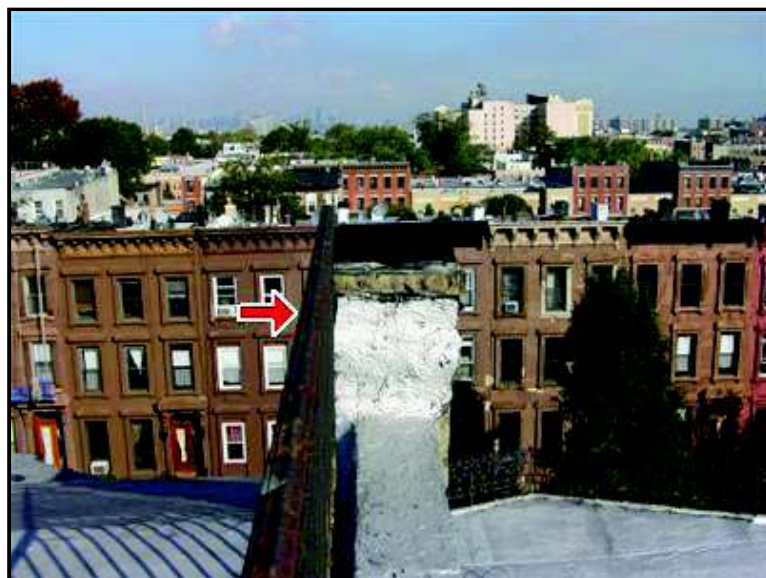
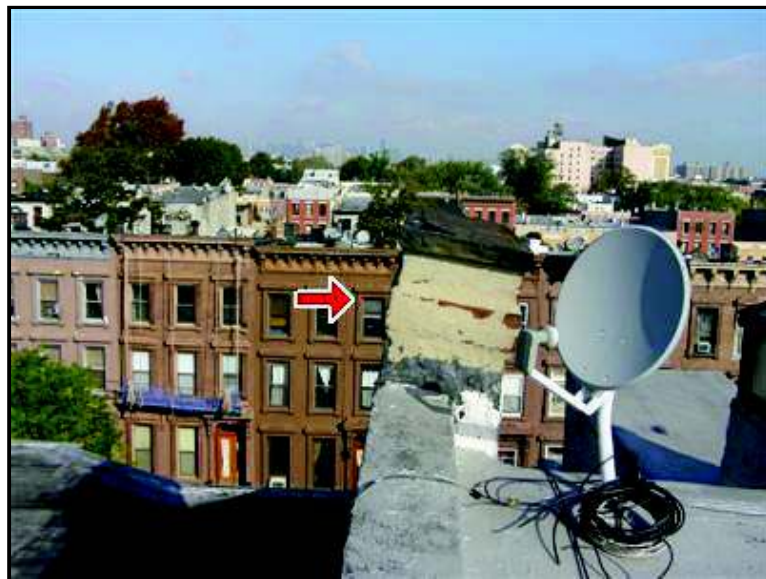
1.2 Picture 3 northeast chimney out of plum

1.2 Picture 4 Northwest chimney out of plum

**Recommend evaluation and repair by a licensed mason contractor to repair chimneys.**

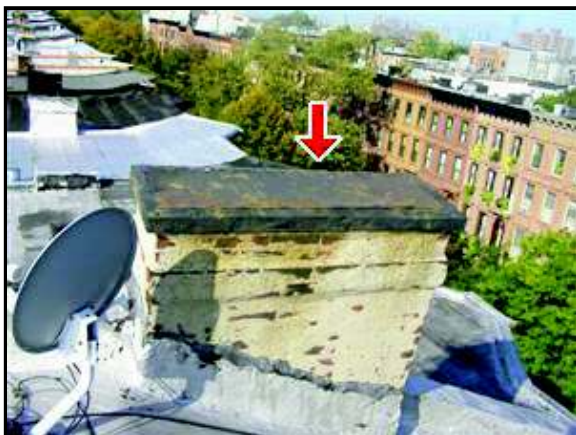
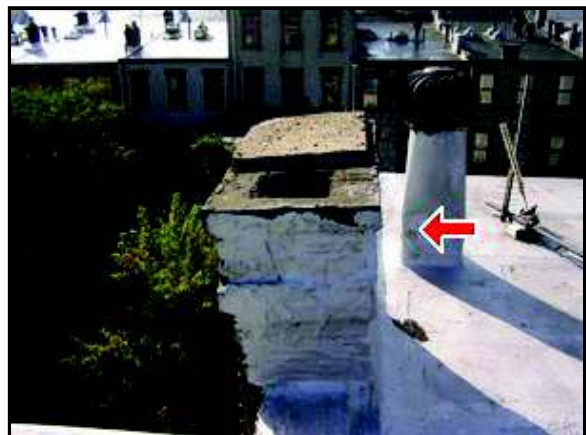
1.2 Picture 5 North west chimney cover over  
fue pipe

1.2 Picture 6 Southeast chimney fireplace  
flues covered

**Recommend evaluation of flue pipe if fireplaces are to be renovated.**

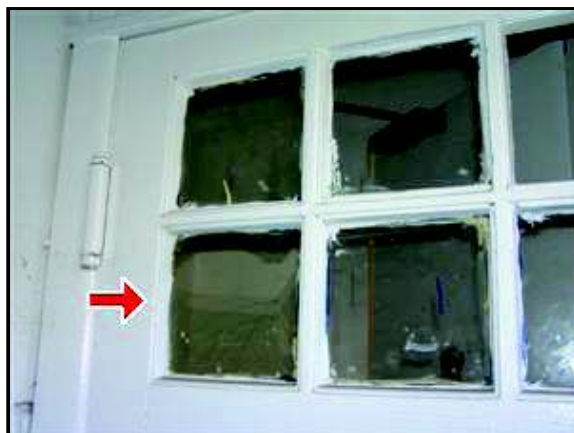
2.1 Picture 1 Broken glass pain

**Front door under steps to ground floor apartment glass pain broken. Recommend evaluation and repair by a licensed window contractor or qualified handy-man.**

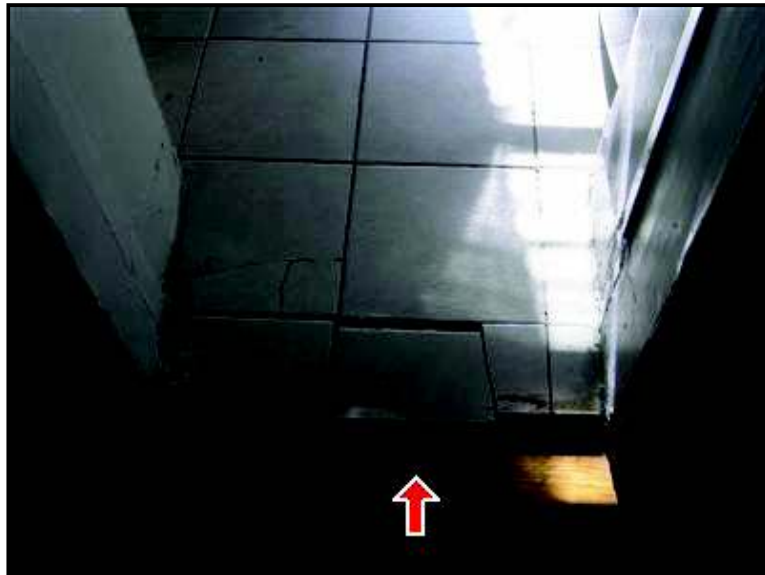
3.2.B Picture 1 Ceramic tile cracked.

**Ceramic tile floor cracked at doorway, should be marble saddle. Recommend evaluation and repair by a licensed tile contractor.**

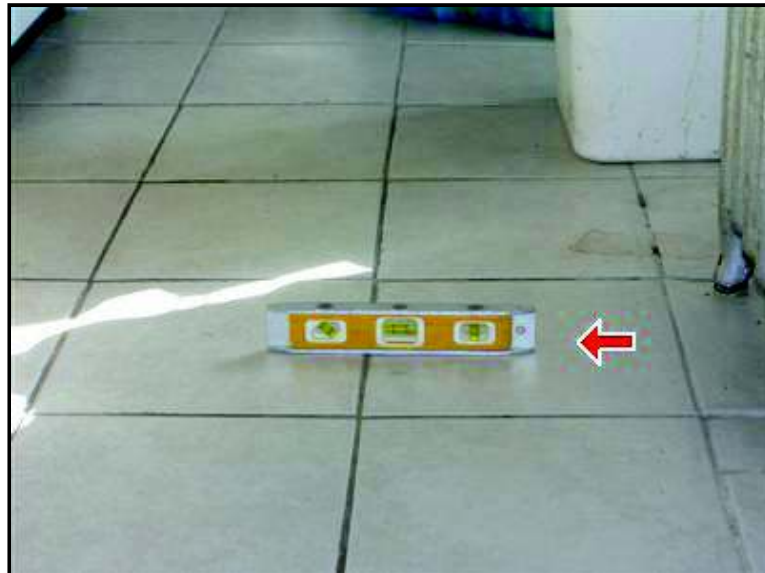
3.2.E Picture 1 Out of level

**Floor is noticeably out of level do to settlement. pitches from rear toward front. Recommend evaluation and leveling by a licensed carpenter contractor.**

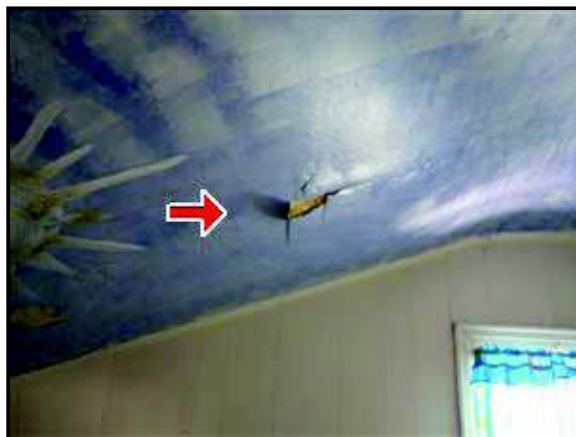
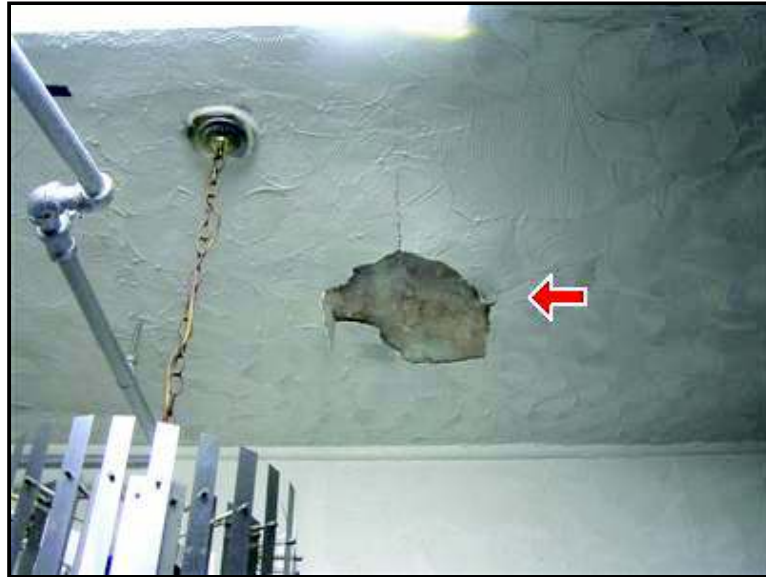
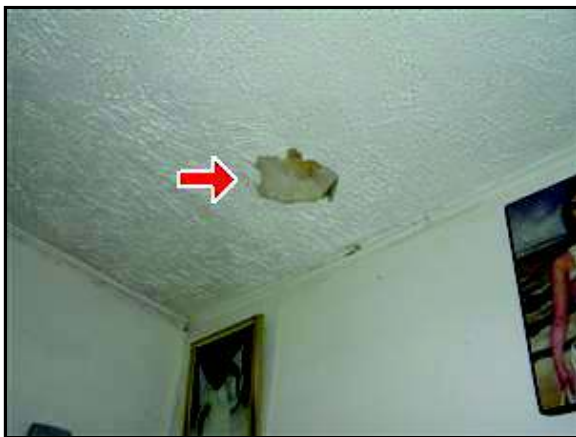
4.0 Picture 2 Middle bedroom plaster cracked and peeling

4.0 Picture 3 Front bedroom plaster cracked and peeling

4.0 Picture 4 5th floor dining room plaster cracked and peeling

**Plaster cracked in middle room and dining.**

**Recommend evaluation and repair by a licensed drywall contractor. Not before roof leaks are repaired.**

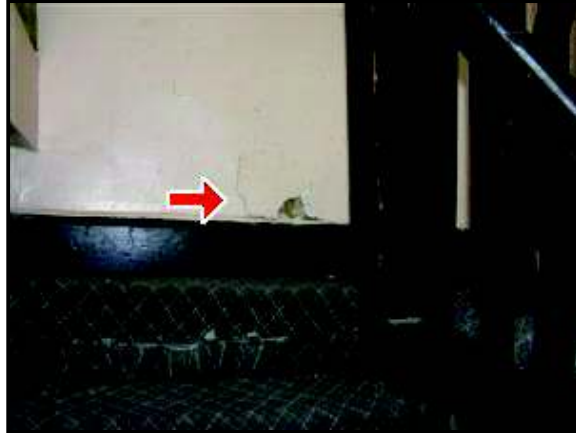
4.1 Picture 1 Hole in plaster at landing to 5th floor

**Hole in plaster at landing to 5th floor. Recommend evaluation and repair by a licensed drywall contractor.**

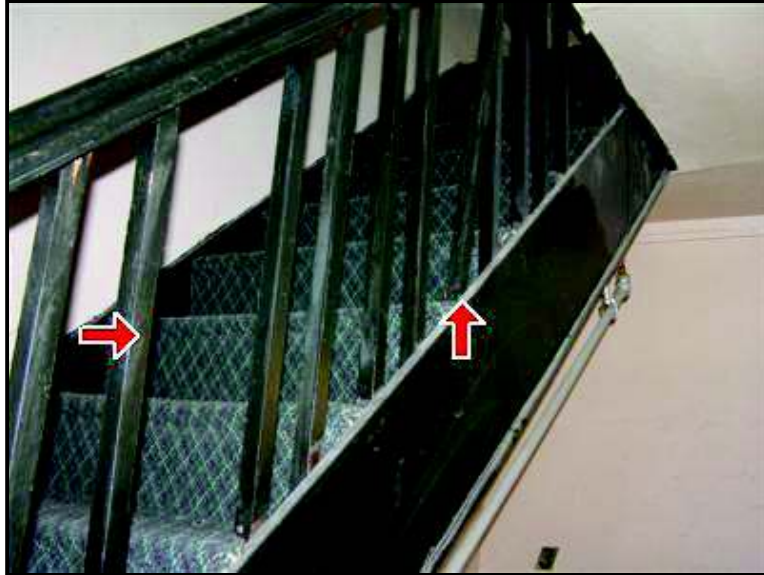
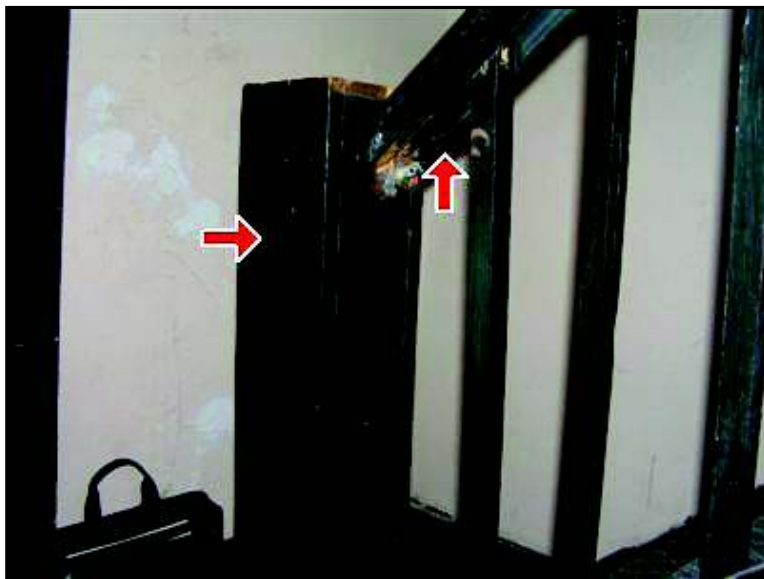
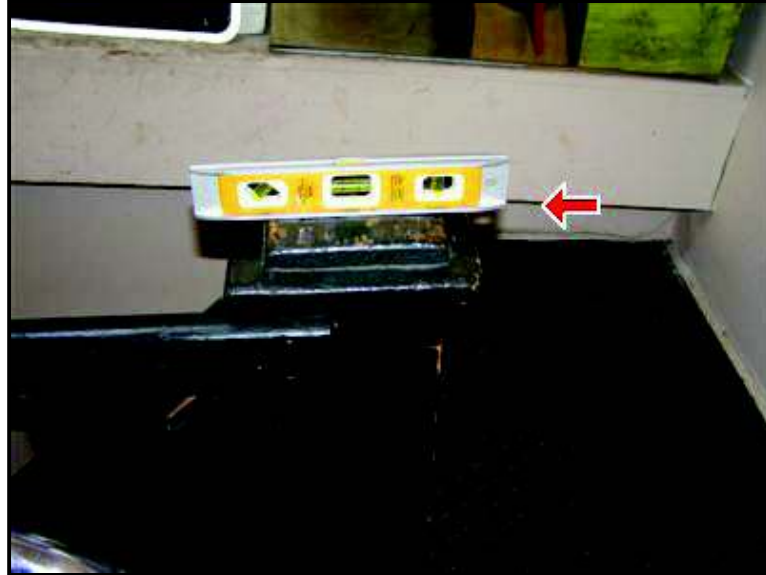
4.3 Picture 1 Missing & loose baluster

4.3 Picture 2 newels loose

4.3 Picture 3 Fifth floor landing and railing pitched

**Railing and newels in stair well are loose with balusters missing and or loose. Fifth floor landing & railing not level. Stairs out of level pitching down toward center of house, from settlement. Recommend evaluation and repair by a licensed carpenter contractor.**

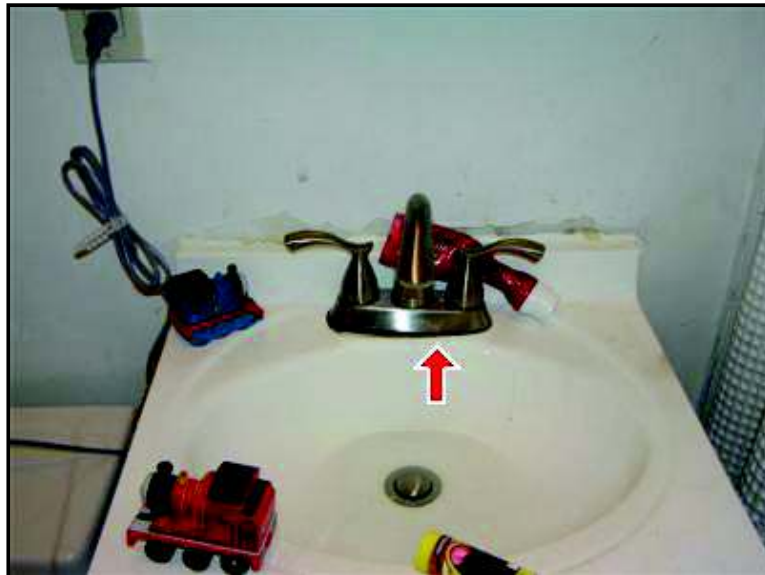
5.4.B Picture 1 Faucet loose

**Water faucet loose, recommend tightening by a qualified handy-man or licensed plumber.**

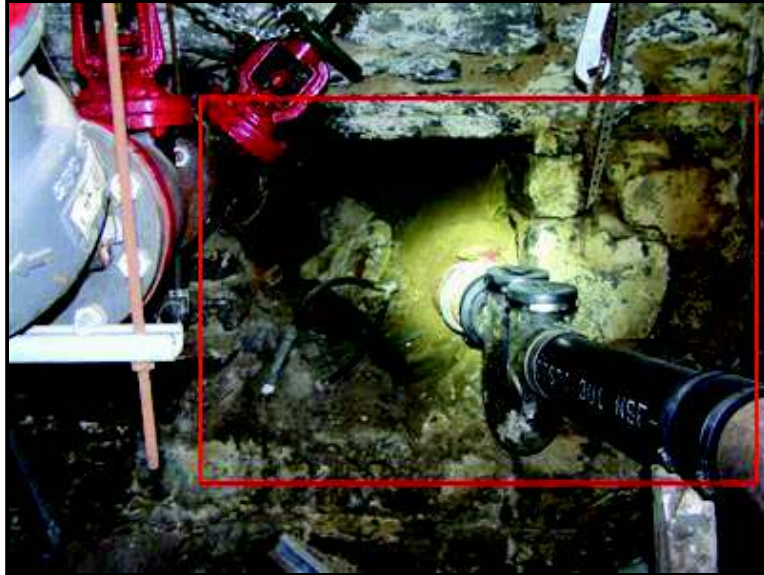
6.0 Picture 1 Hole in foundation

**Large hole in stone foundation at northeast corner at water service and waste line entrance. Recommend evaluation and repair by a licensed mason contractor.**

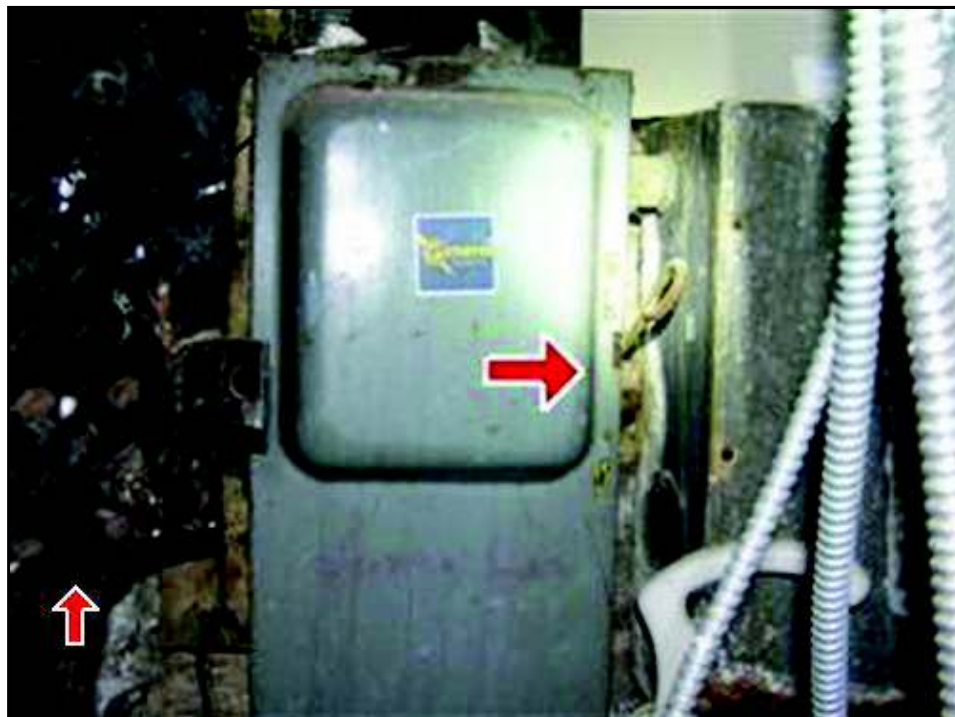
6.0 Picture 2 Steel door won't open

**Steel door to fresh air vent at north west corner of basement does not clear meter pan to open. Recommend evaluation and repair by a licensed welding and metal fabrication contractor.**

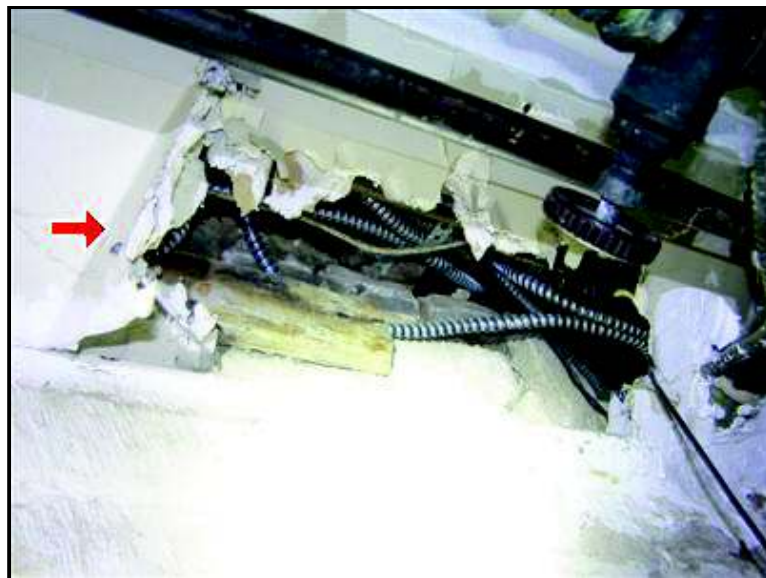
6.4 Picture 1 Not 5/8" sheet rock

**Hole in fire proofing sheet rock. Sheet rock should be 5/8" minimum for fire proofing. Recommend evaluation and repair by a licensed drywall contractor.**

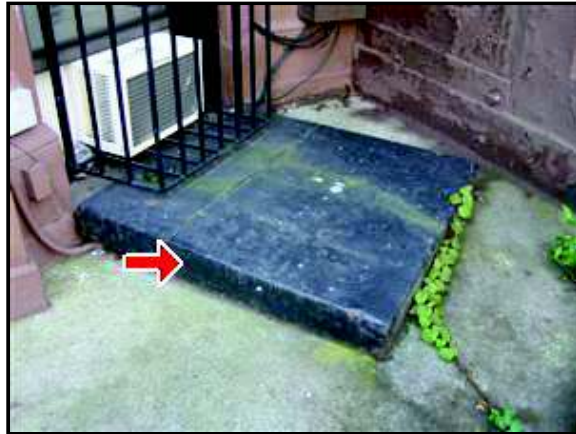
6.6 Picture 1 Basement vent cvered

**Original basement vent covered**

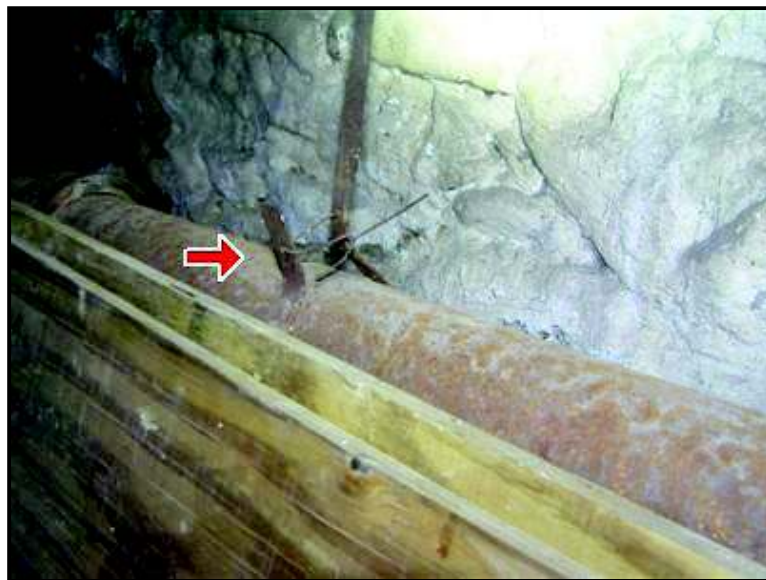
7.0 Picture 2 Hanger bracket not secured properly

**Cast iron waste line hanger bracket should be bolted together not wired**

**Recommend evaluation and repair by a licensed plumbing contractor.**

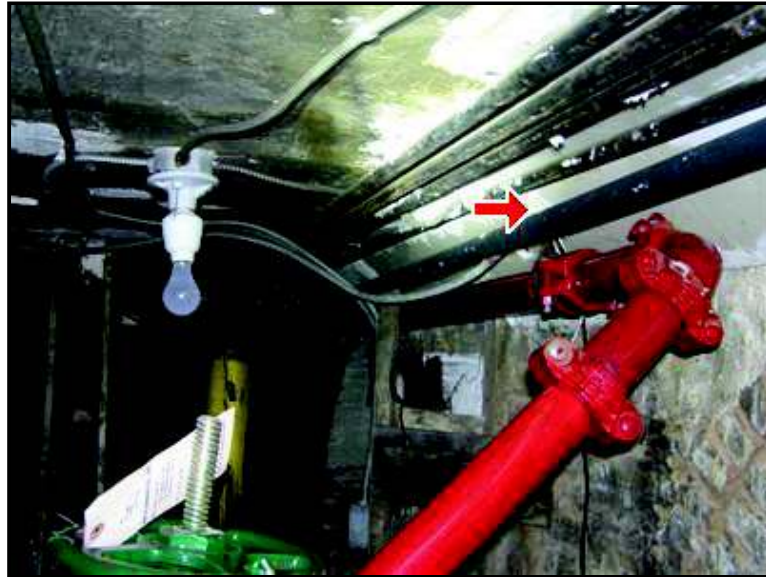
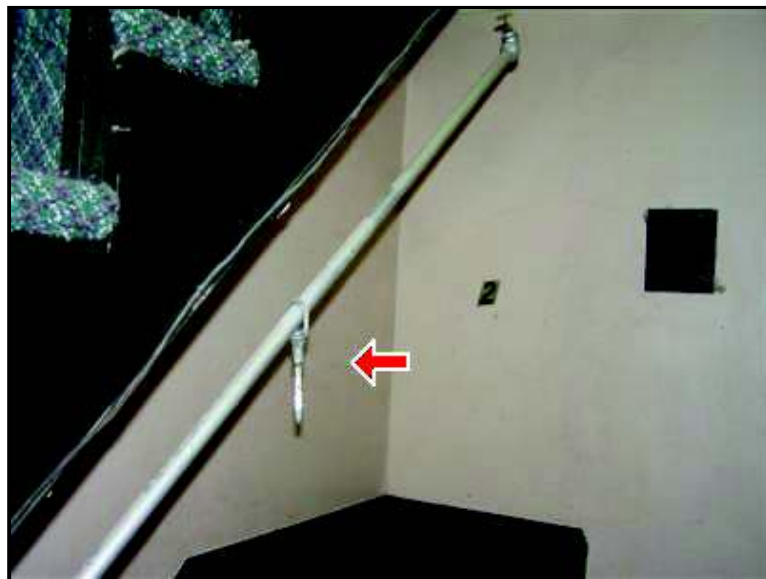
7.1 Picture 1 1" water pipe not supported

7.1 Picture 2 Support eye pulled out o

**One inch brass water pipe not supported, hanging on steam pipes. Fire sprinkler pipe not supported in stairwell. Support eye pulled out of stair stringer, at third floor landing. Recommend evaluation and repair by a licensed plumbing contractor.**

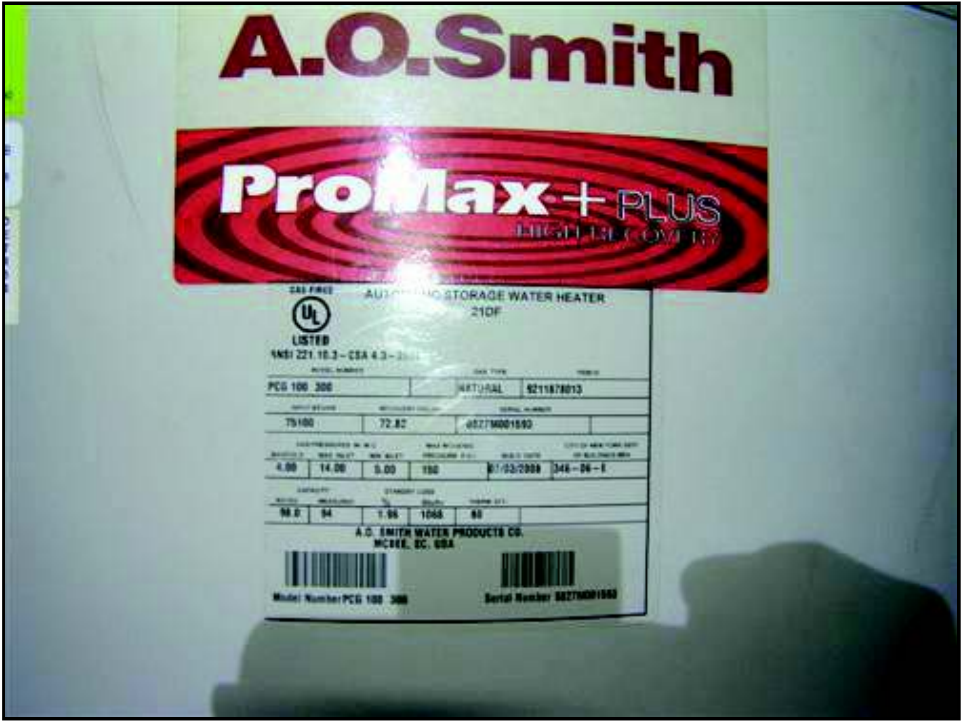
7.2 Picture 1 75 Gal AO Smith Water Heater

**Water heater flue to chimney needs to be repaired by a licensed HAVAC contractor.**

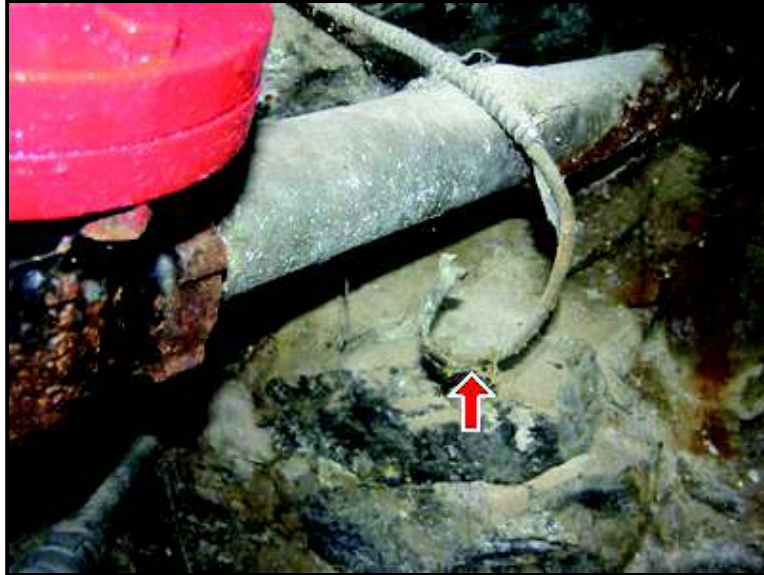
8.1 Picture 1 Ground not secured to water main

**Caution: Ground wire not secured to water main.**

**Recommend evaluation and repair by a licensed electrical contractor**

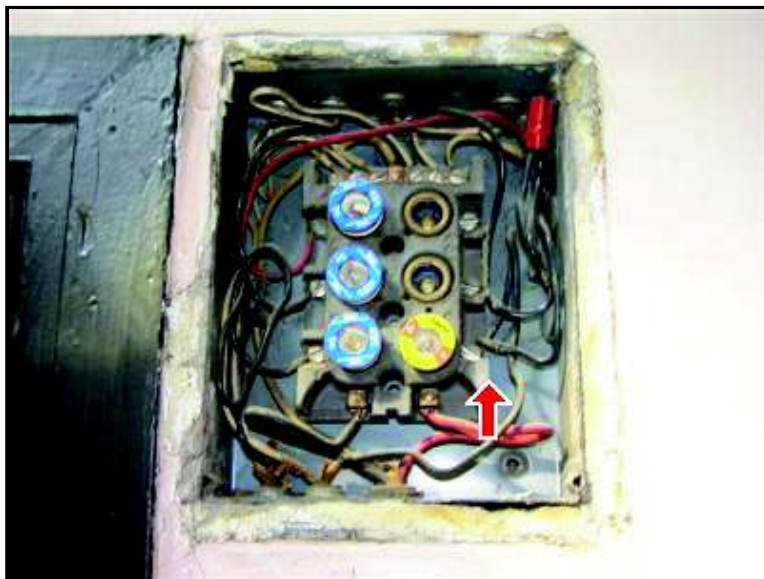
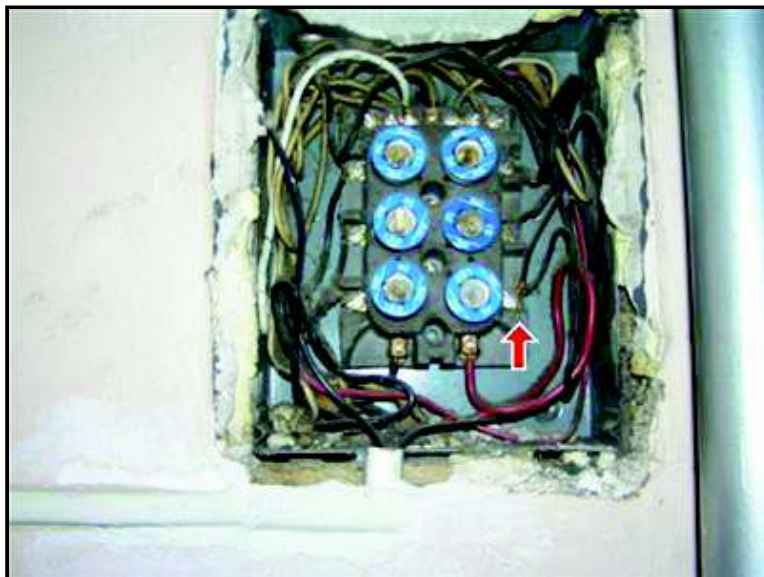
8.1 Picture 2 5th floor panel, fuse doubled lugged

8.1 Picture 3 4th floor panel, fuse double lugged

**Recommend conversion of fuse panels to circuit breaker panels to prevent over fuseing by tenants.**

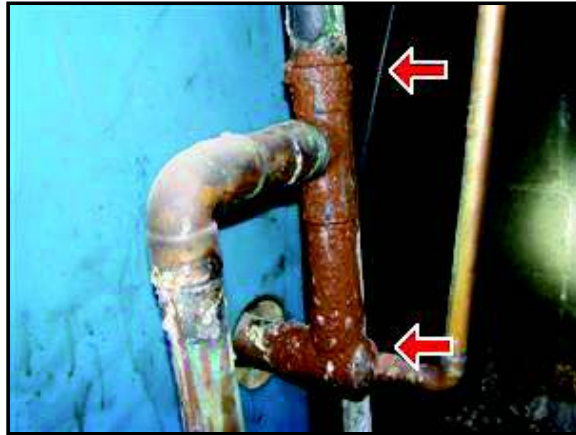
9.3 Picture 1 Leaking condensate return

**Condensate return line leaking at rear of boiler.**

**Recommend evaluation and repair by a licensed plumbing contractor.**

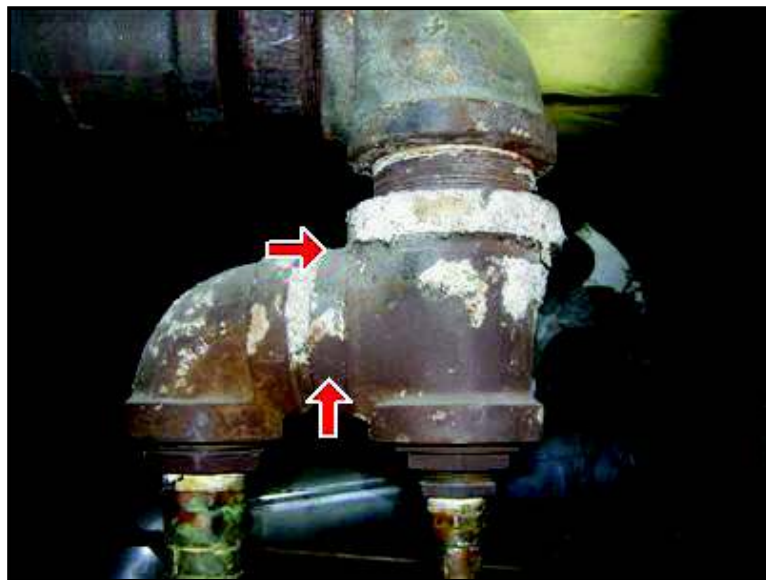
9.3 Picture 2 Some asbestoes residue left on pipes above boiler

**Caution: Some asbestos residue left on pipes above boiler. Recommend evaluation and removal by a licensed asbestos abatement contractor.**

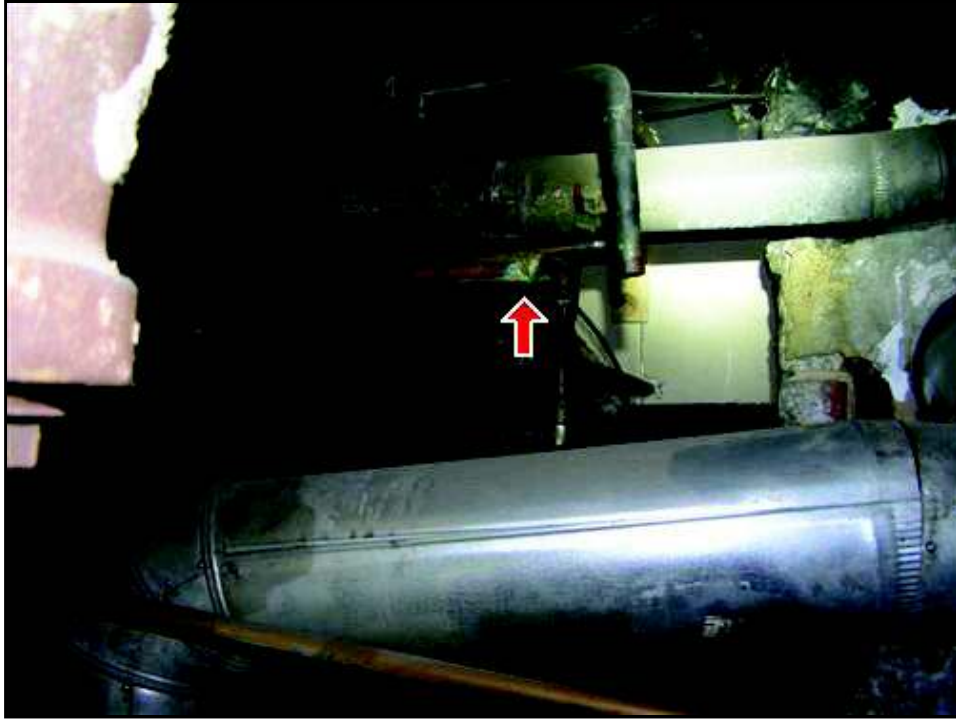
9.3 Picture 4 elbow corroded

**1/2" water line above boiler corroded at elbow.**

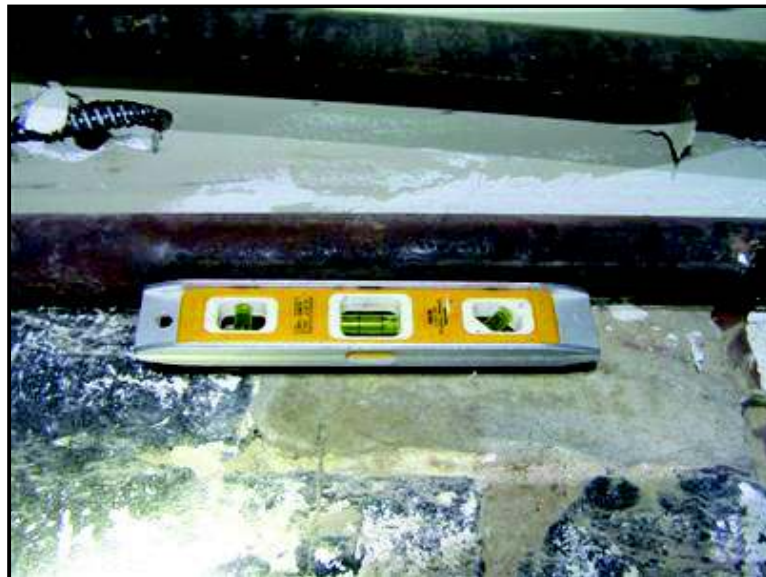
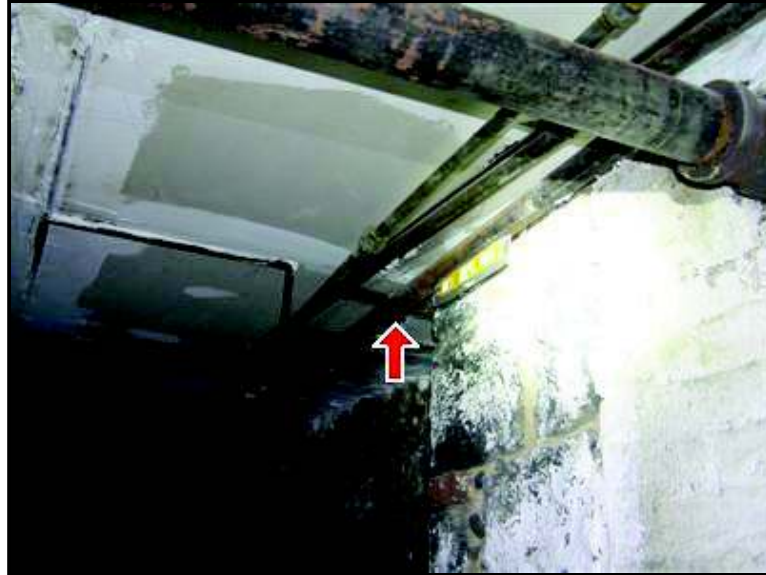
9.3 Picture 5 Steam pipe pitched wrong

9.3 Picture 6 Steam pipe pitched wrong

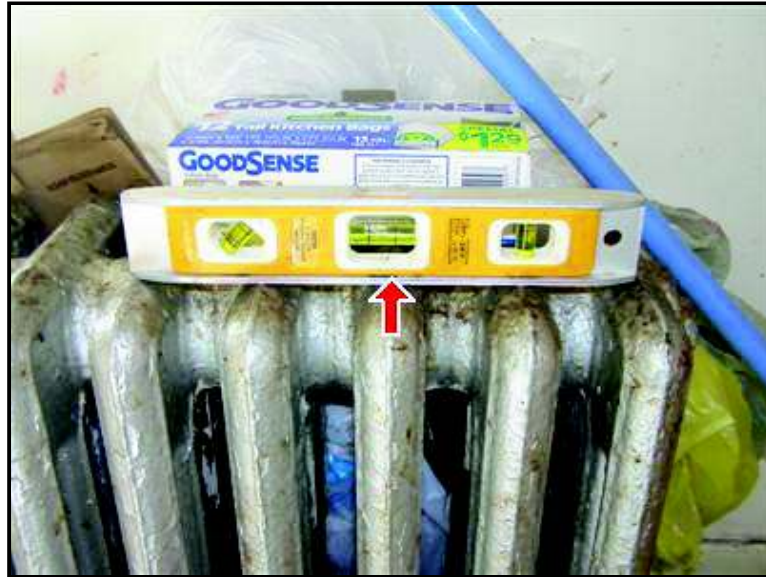
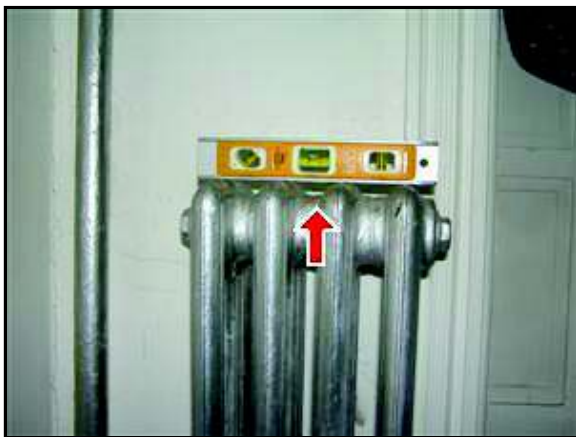
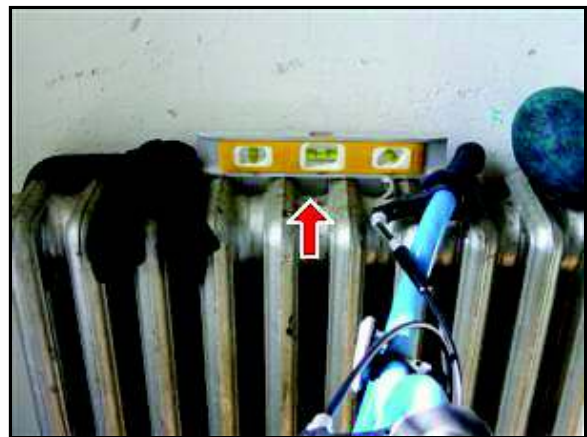
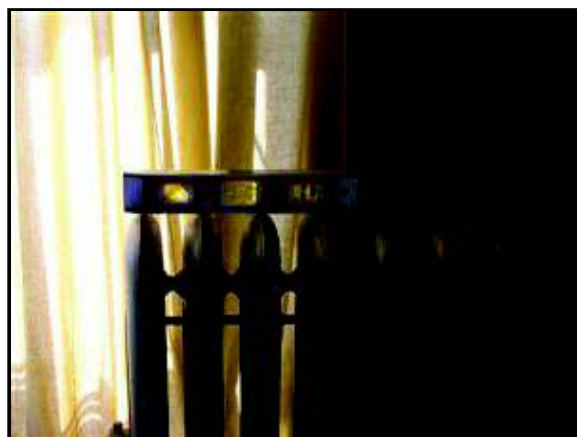
9.4 Picture 1 Radiator, 5th floor kitchen pitched wrong way

9.4 Picture 2 Radiator in 4th floor front room pitched wrong way

9.4 Picture 3 Radiator in 3rd floor kitchen pitched wrong way

9.4 Picture 4 Radiator in 3rd floor bedroom pitched wrong way

**Radiator in 5th floor kitchen pitched wrong way.**

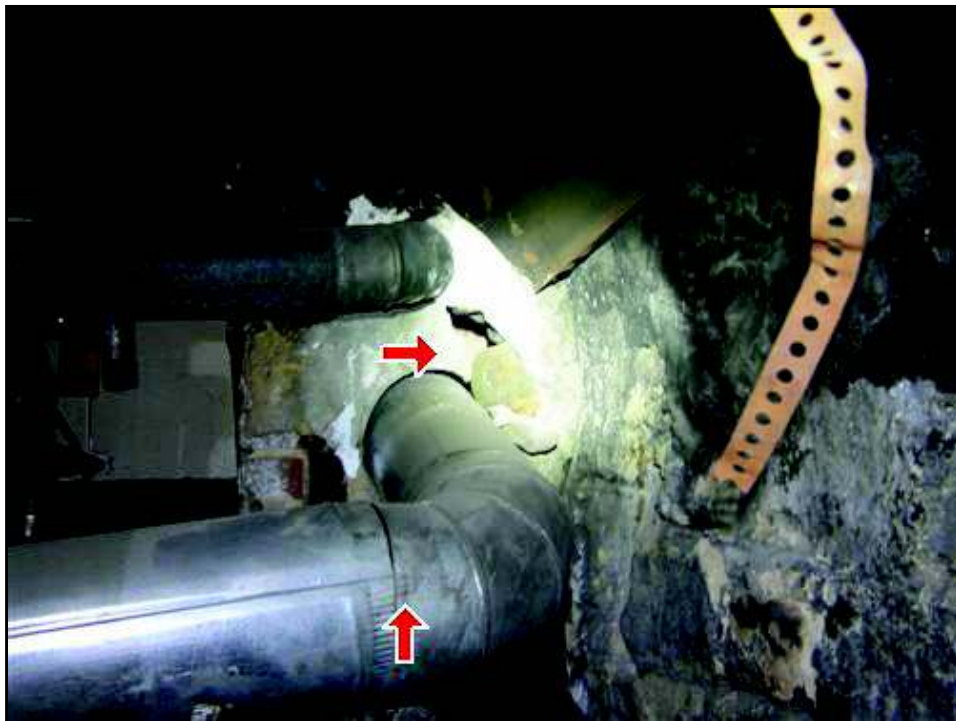
9.5 Picture 1 Open joint and chimney repair

**Caution: Carbon-monoxide gas, flu pipe separated at elbow and opening at chimney entrance. Flue pipe should be screwed together. Recommend evaluation and repair by a licensed HAVAC contractor.**

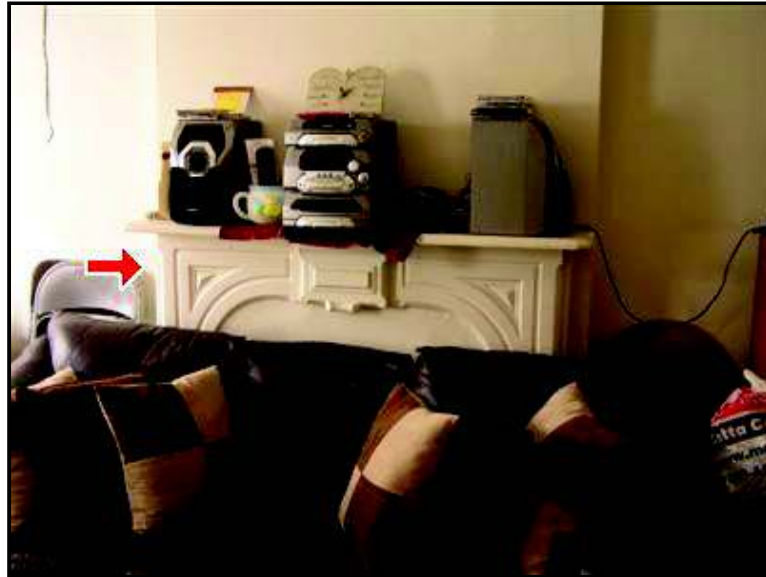
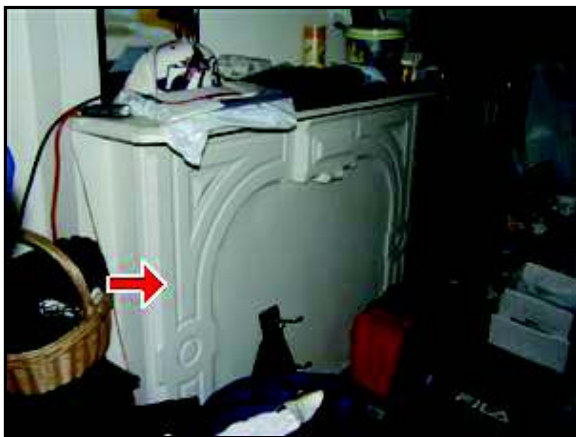
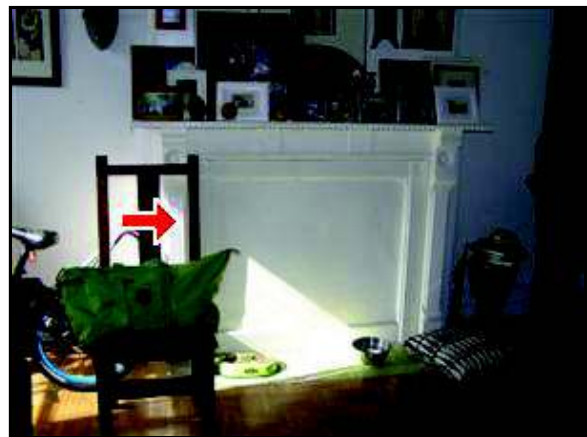
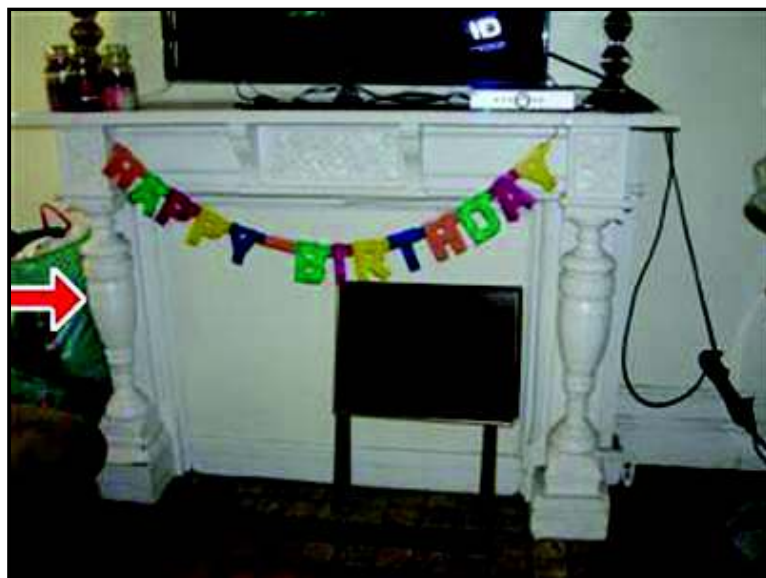
9.6 Picture 1 4th floor rear room

**Fireplaces covered over through out house. If fireplaces are to be activated, the flue pipe and dampers need to be evaluated and covers removed from chimneys and hearths. By a licensed mason contractor with experience with fireplaces.**
